Global Property Inspections

Jeff Ham Team The Fresh Approach, 4267 Bridlepath Trail, Mississauga, ON, L5L 3K3

July 14, 2020

Inspection Date:
07-14-2020

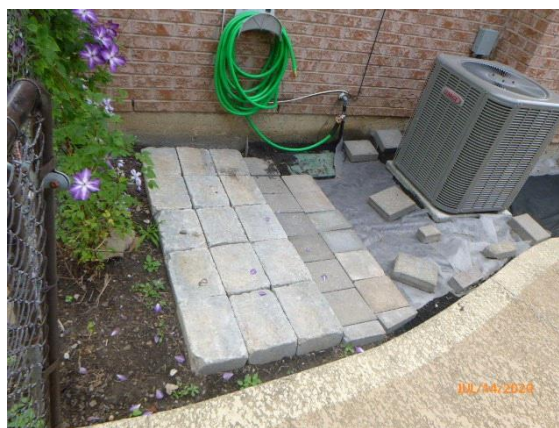
Negative grading was noted at side/s and rear of dwelling. Likely to cause drainage problems during rainfall. Recommend repair to prevent water intrusion.

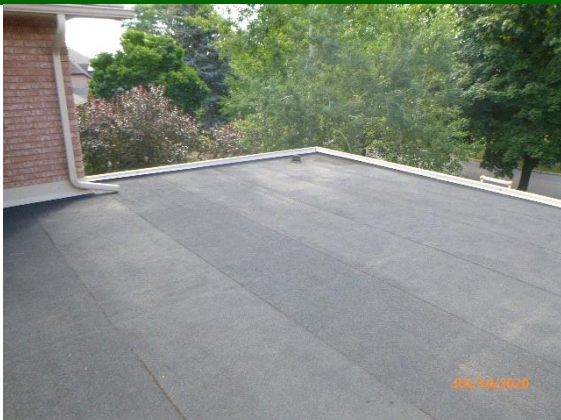
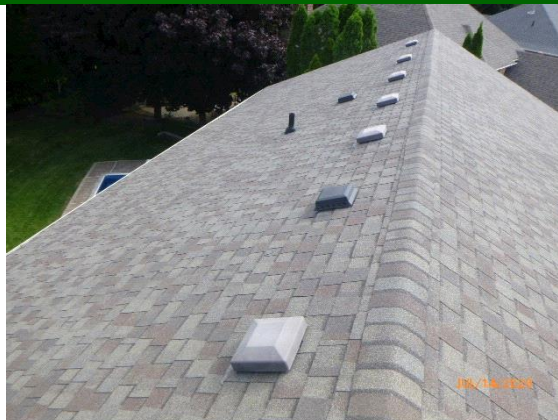
Leaks not always detectable.

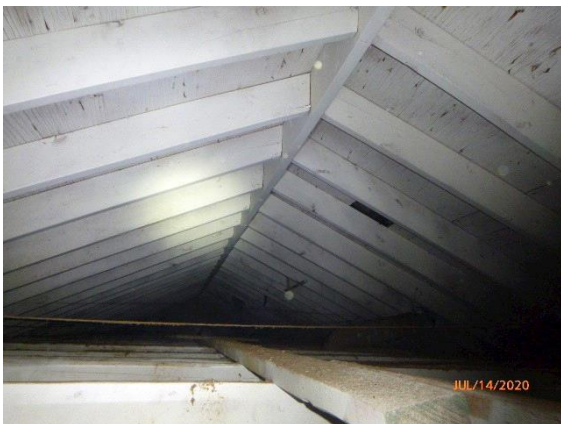
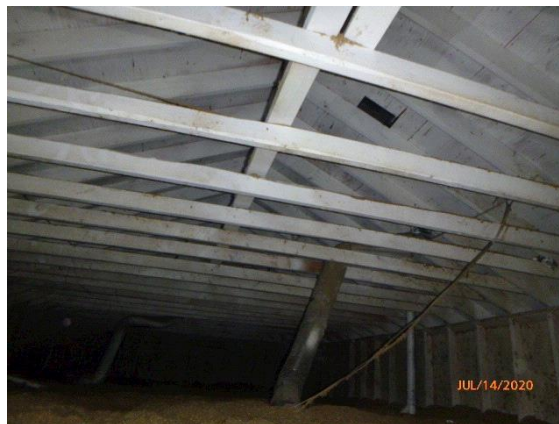
Leaks not always detectable.

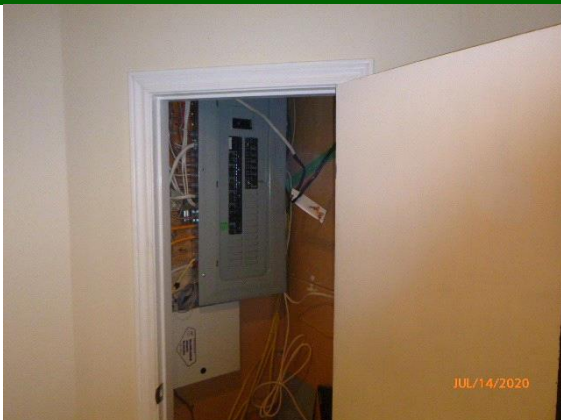
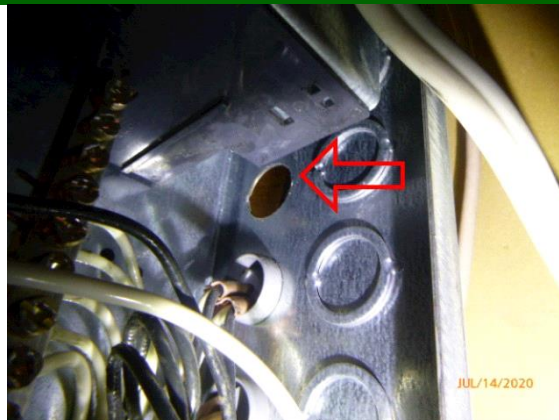
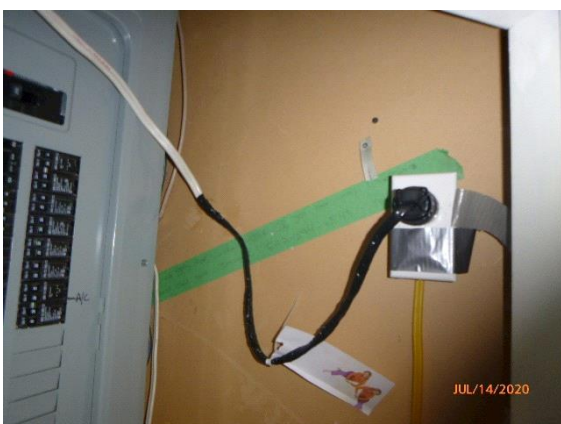
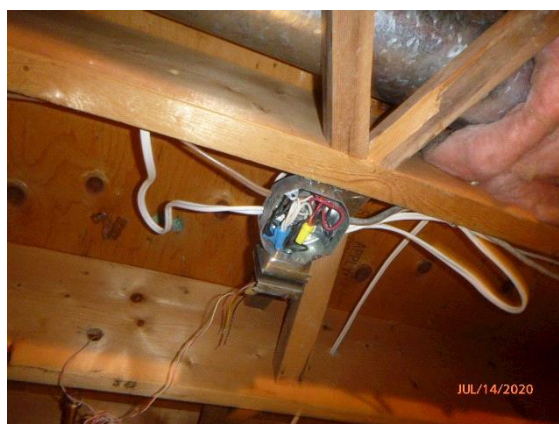
Inadequate clearance/working space was noted in front of electrical panel. Panel was not fully labelled. Open knock-out/s were present in panel. Electrical conductor for pool pump was not installed properly. All electrical outlets, switches and junction boxes require cover plates for safety. Recommend repair by a qualified electrician.

Smoke detector in basement was not working. Recommend replacement.

Recommend installation of carbon monoxide detectors where needed for safety.
