Global Property Inspections

Jeff Ham Team The Fresh Approach, 545342 Pattullo Avenue, Woodstock, ON, N4S 7W3

July 14, 2020

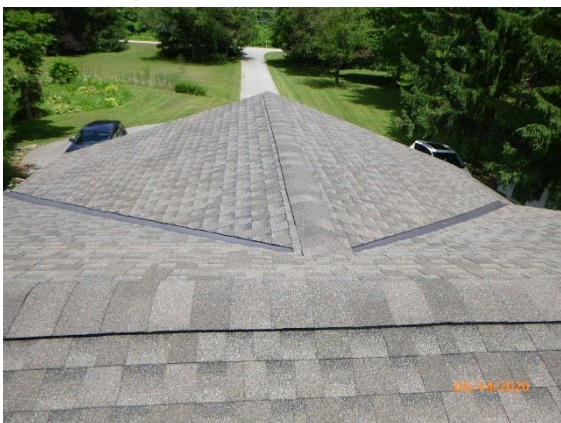
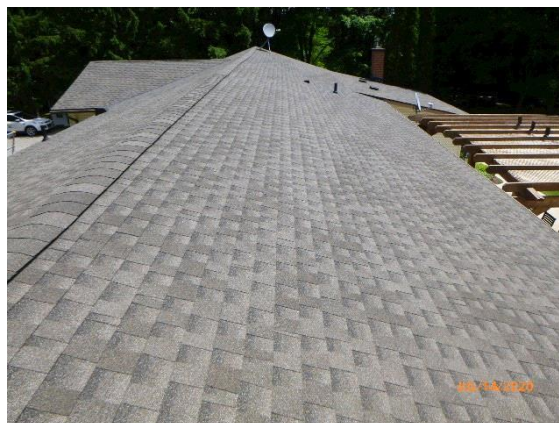
Roofing:

Age: 5-10 Year(s)

Design Life: 15-20 Year(s)

Layers: 1

☒ Asphalt / Composition

Keep trees and branches trimmed to prevent damage to roof covering.

Leaks not always detectable.

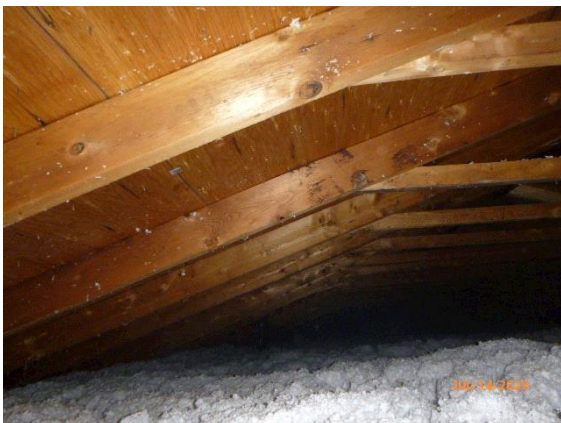
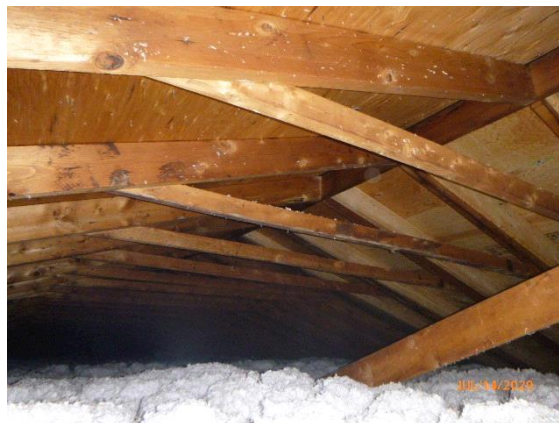
Attic Framing/Sheathing:

☒ Plywood / Panel Board / OSB ☒ Rafters

Leaks not always detectable.

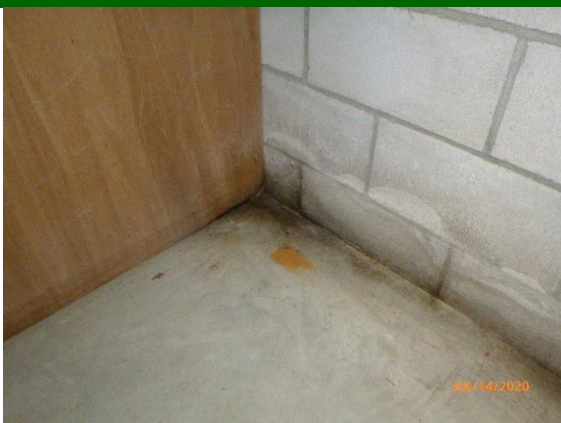
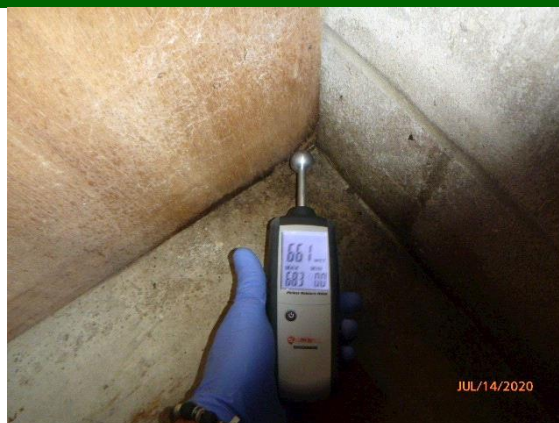
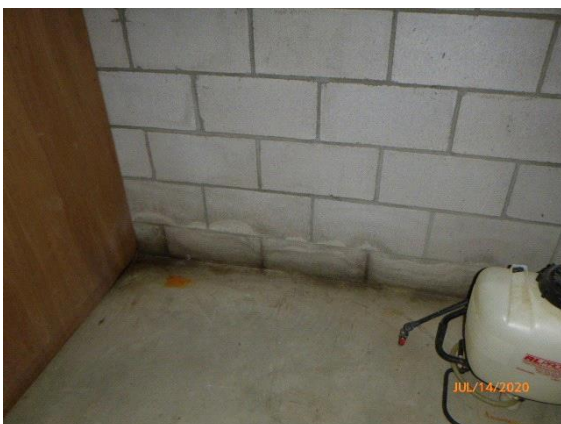
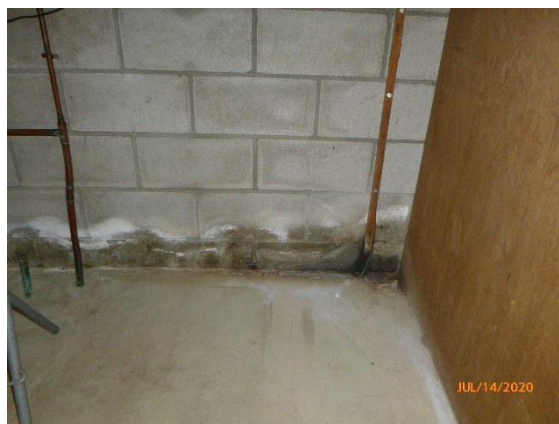
Interior Foundation:

☒ Efflorescence / Suspected Leak(s)

☒ Step Cracks

Limited observation due to finish and stored items.

Visible evidence of moisture was observed and elevated levels of moisture were detected along west wall of basement. Recommend further evaluation and any/all necessary repairs to stop/eliminate water intrusion by a qualified contractor.

Visible evidence of moisture was observed and elevated levels of moisture were detected along west wall of basement. Recommend further evaluation and any/all necessary repairs to stop/eliminate water intrusion by a qualified contractor.

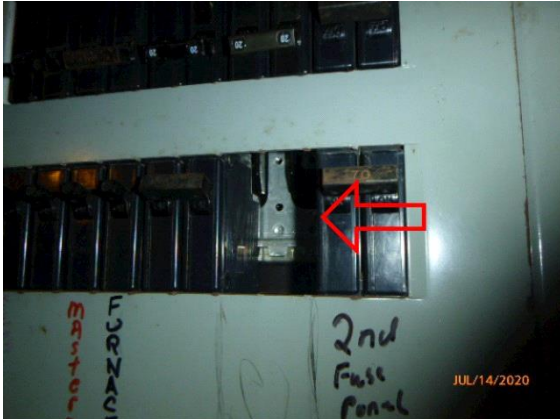
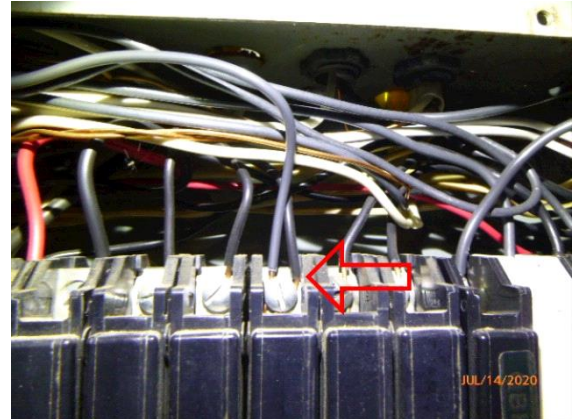
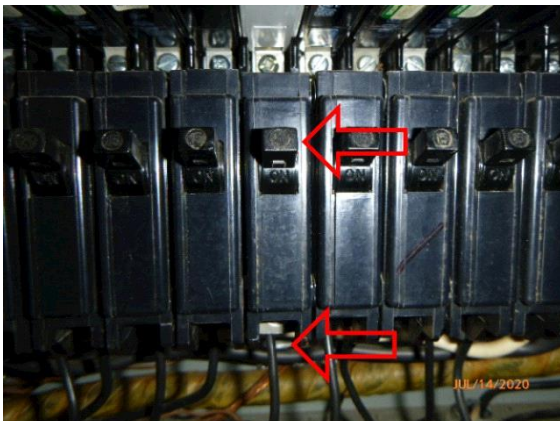
Electrical:

Panel was not fully labelled. Open knock-out/s were present in panel. One breaker in panel was double-tapped. Undersized wires were noted at breaker/s in service panel. Recommend further evaluation and repair by a qualified electrician.

*Smoke Detectors / GFCI's checked with test button only. Monthly Test Recommended.

Recommend installation of carbon monoxide detectors where needed for safety.

Panel was not fully labelled. Open knock-out/s were present in panel. One breaker in panel was double-tapped. Undersized wires were noted at breaker/s in service panel. Recommend further evaluation and repair by a qualified electrician.
Recommend installation of carbon monoxide detectors where needed for safety.

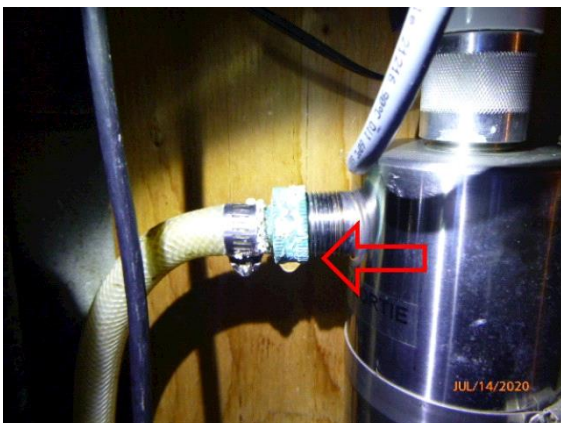
Plumbing:

Water leak was observed at fitting on UV light. Recommend repair by qualified plumber.

Water leak was observed at fitting on UV light. Recommend repair by qualified plumber.

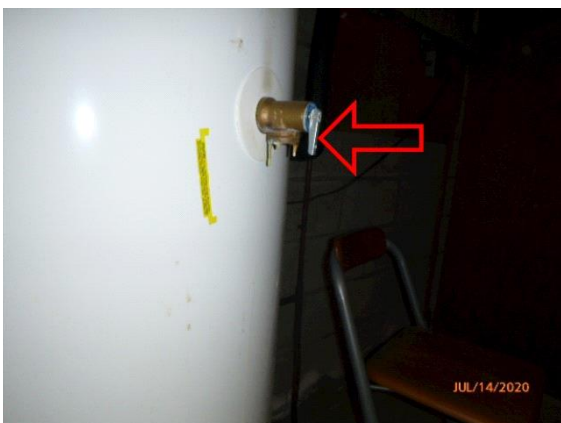
Water Heater:

☒ Missing / Improper Pressure Relief Valves / Extension

Temperature/pressure relief valve tube must exit within 6" of floor. Recommend repair by qualified plumber. Water heater was beyond design life. Monitor for repair/replacement.

Temperature/pressure relief valve tube must exit within 6" of floor. Recommend repair by qualified plumber.
Water heater was beyond design life. Monitor for repair/replacement.

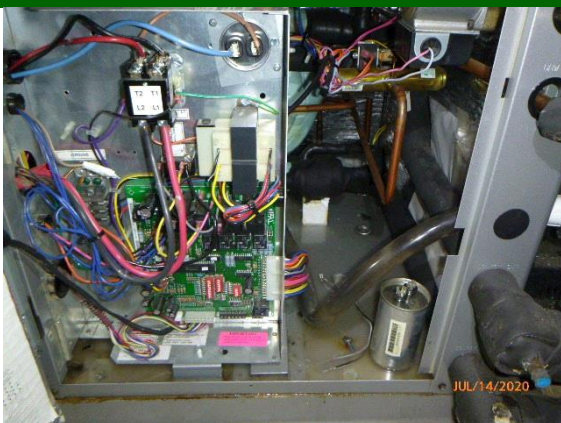
Heating:

Water Furnace was tested in cooling mode. Humidifier was not operating at time of inspection. Not inspected.

Standing water was observed in bottom of unit. Recommend further evaluation and repair by qualified HVAC contractor.

Heat Exchanger - Unable to detect cracks/holes without dismantling unit.

Recommend routine inspection, maintenance and cleaning by qualified HVAC contractor.

Standing water was observed in bottom of unit. Recommend further evaluation and repair by qualified HVAC contractor.

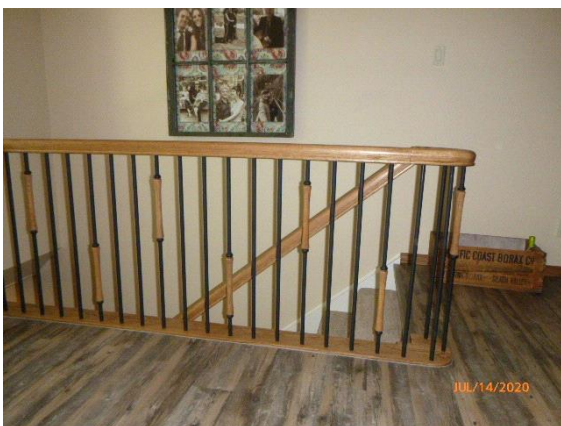
Stairs / Railings:

☒ Missing Hand Rail

Stair railing was not tall enough, should be 36". Recommend repair/replacement for safety.

All stairs/steps with 4 or more risers require hand rail for safety. Recommend installation of hand rails by qualified contractor for safety.

Stair railing was not tall enough, should be 36". Recommend repair/replacement for safety.

All stairs/steps with 4 or more risers require hand rail for safety. Recommend installation of hand rails by qualified contractor for safety.
